# **DAMAGE MITIGATION STRATEGIES**

# **NON-STRUCTURAL INFILL WALLS**

A thesis submitted in partial fulfilment of the  
requirements for the Degree of  
Doctor of Philosophy in Civil Engineering  
by

Department of Civil and Natural Resources Engineering  
University of Canterbury  
Christchurch, New Zealand

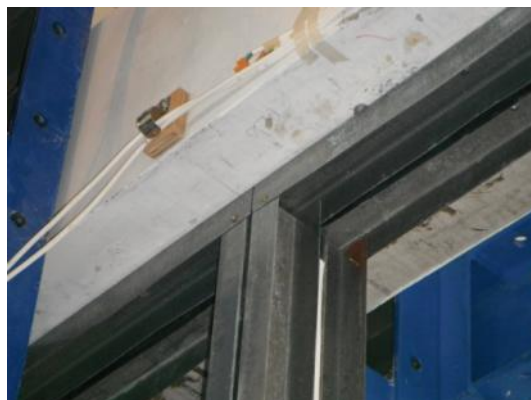
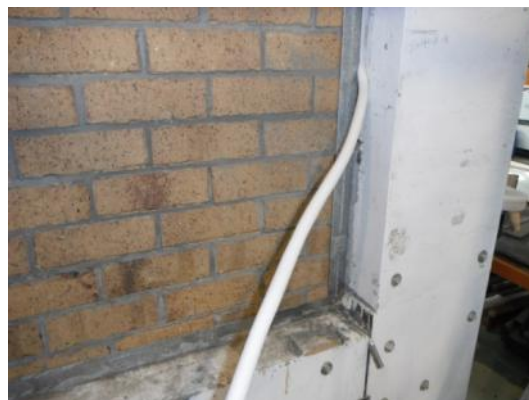
**Figure 0.48.** Low damage unreinforced clay brick infill wall specimen MIF5-UCBI: a) The sub-frame system, b) The clay bricks infilled within the sub-frame

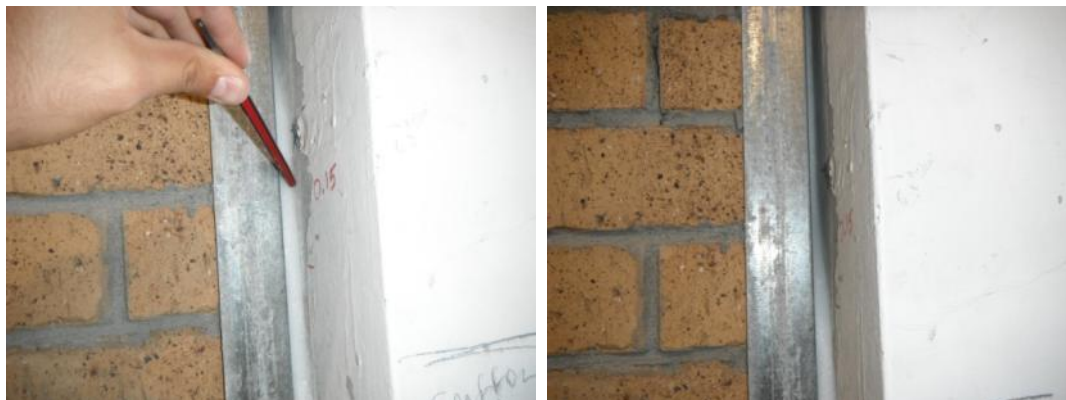
**Figure 0.49.** Low damage unreinforced clay brick infill wall specimen MIF5-UCBI: The installation of the polyethylene foam

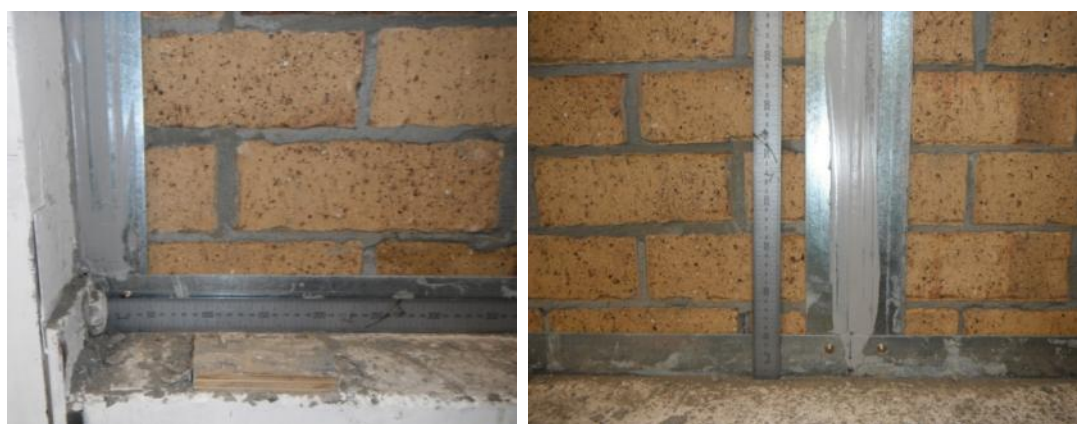
**Figure 0.50.** Low damage unreinforced clay brick infill wall specimen MIF5-UCBI after the installation of the polyurethane structural joint sealant

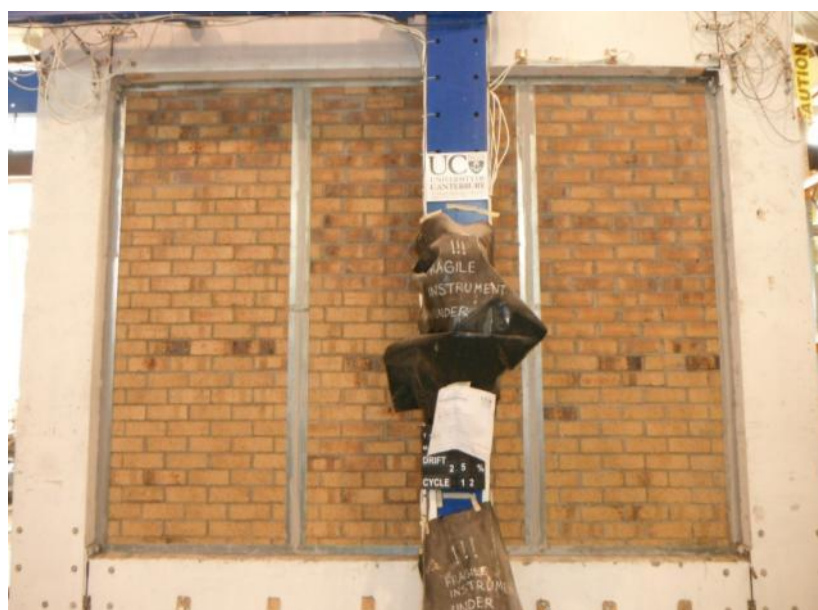
**Figure 0.51.** Completed low damage unreinforced clay brick infill wall specimen MIF5-UCBI
